# EXISTING AGRICULTURAL DRAIN TILE INVESTIGATION PLAN

# YORKVILLE 50TH ROAD

PREPARED FOR TNG27, LLC

### EXISTING SUBSURFACE AGRICULTURAL DRAIN TILE INVESTIGATION REPORT

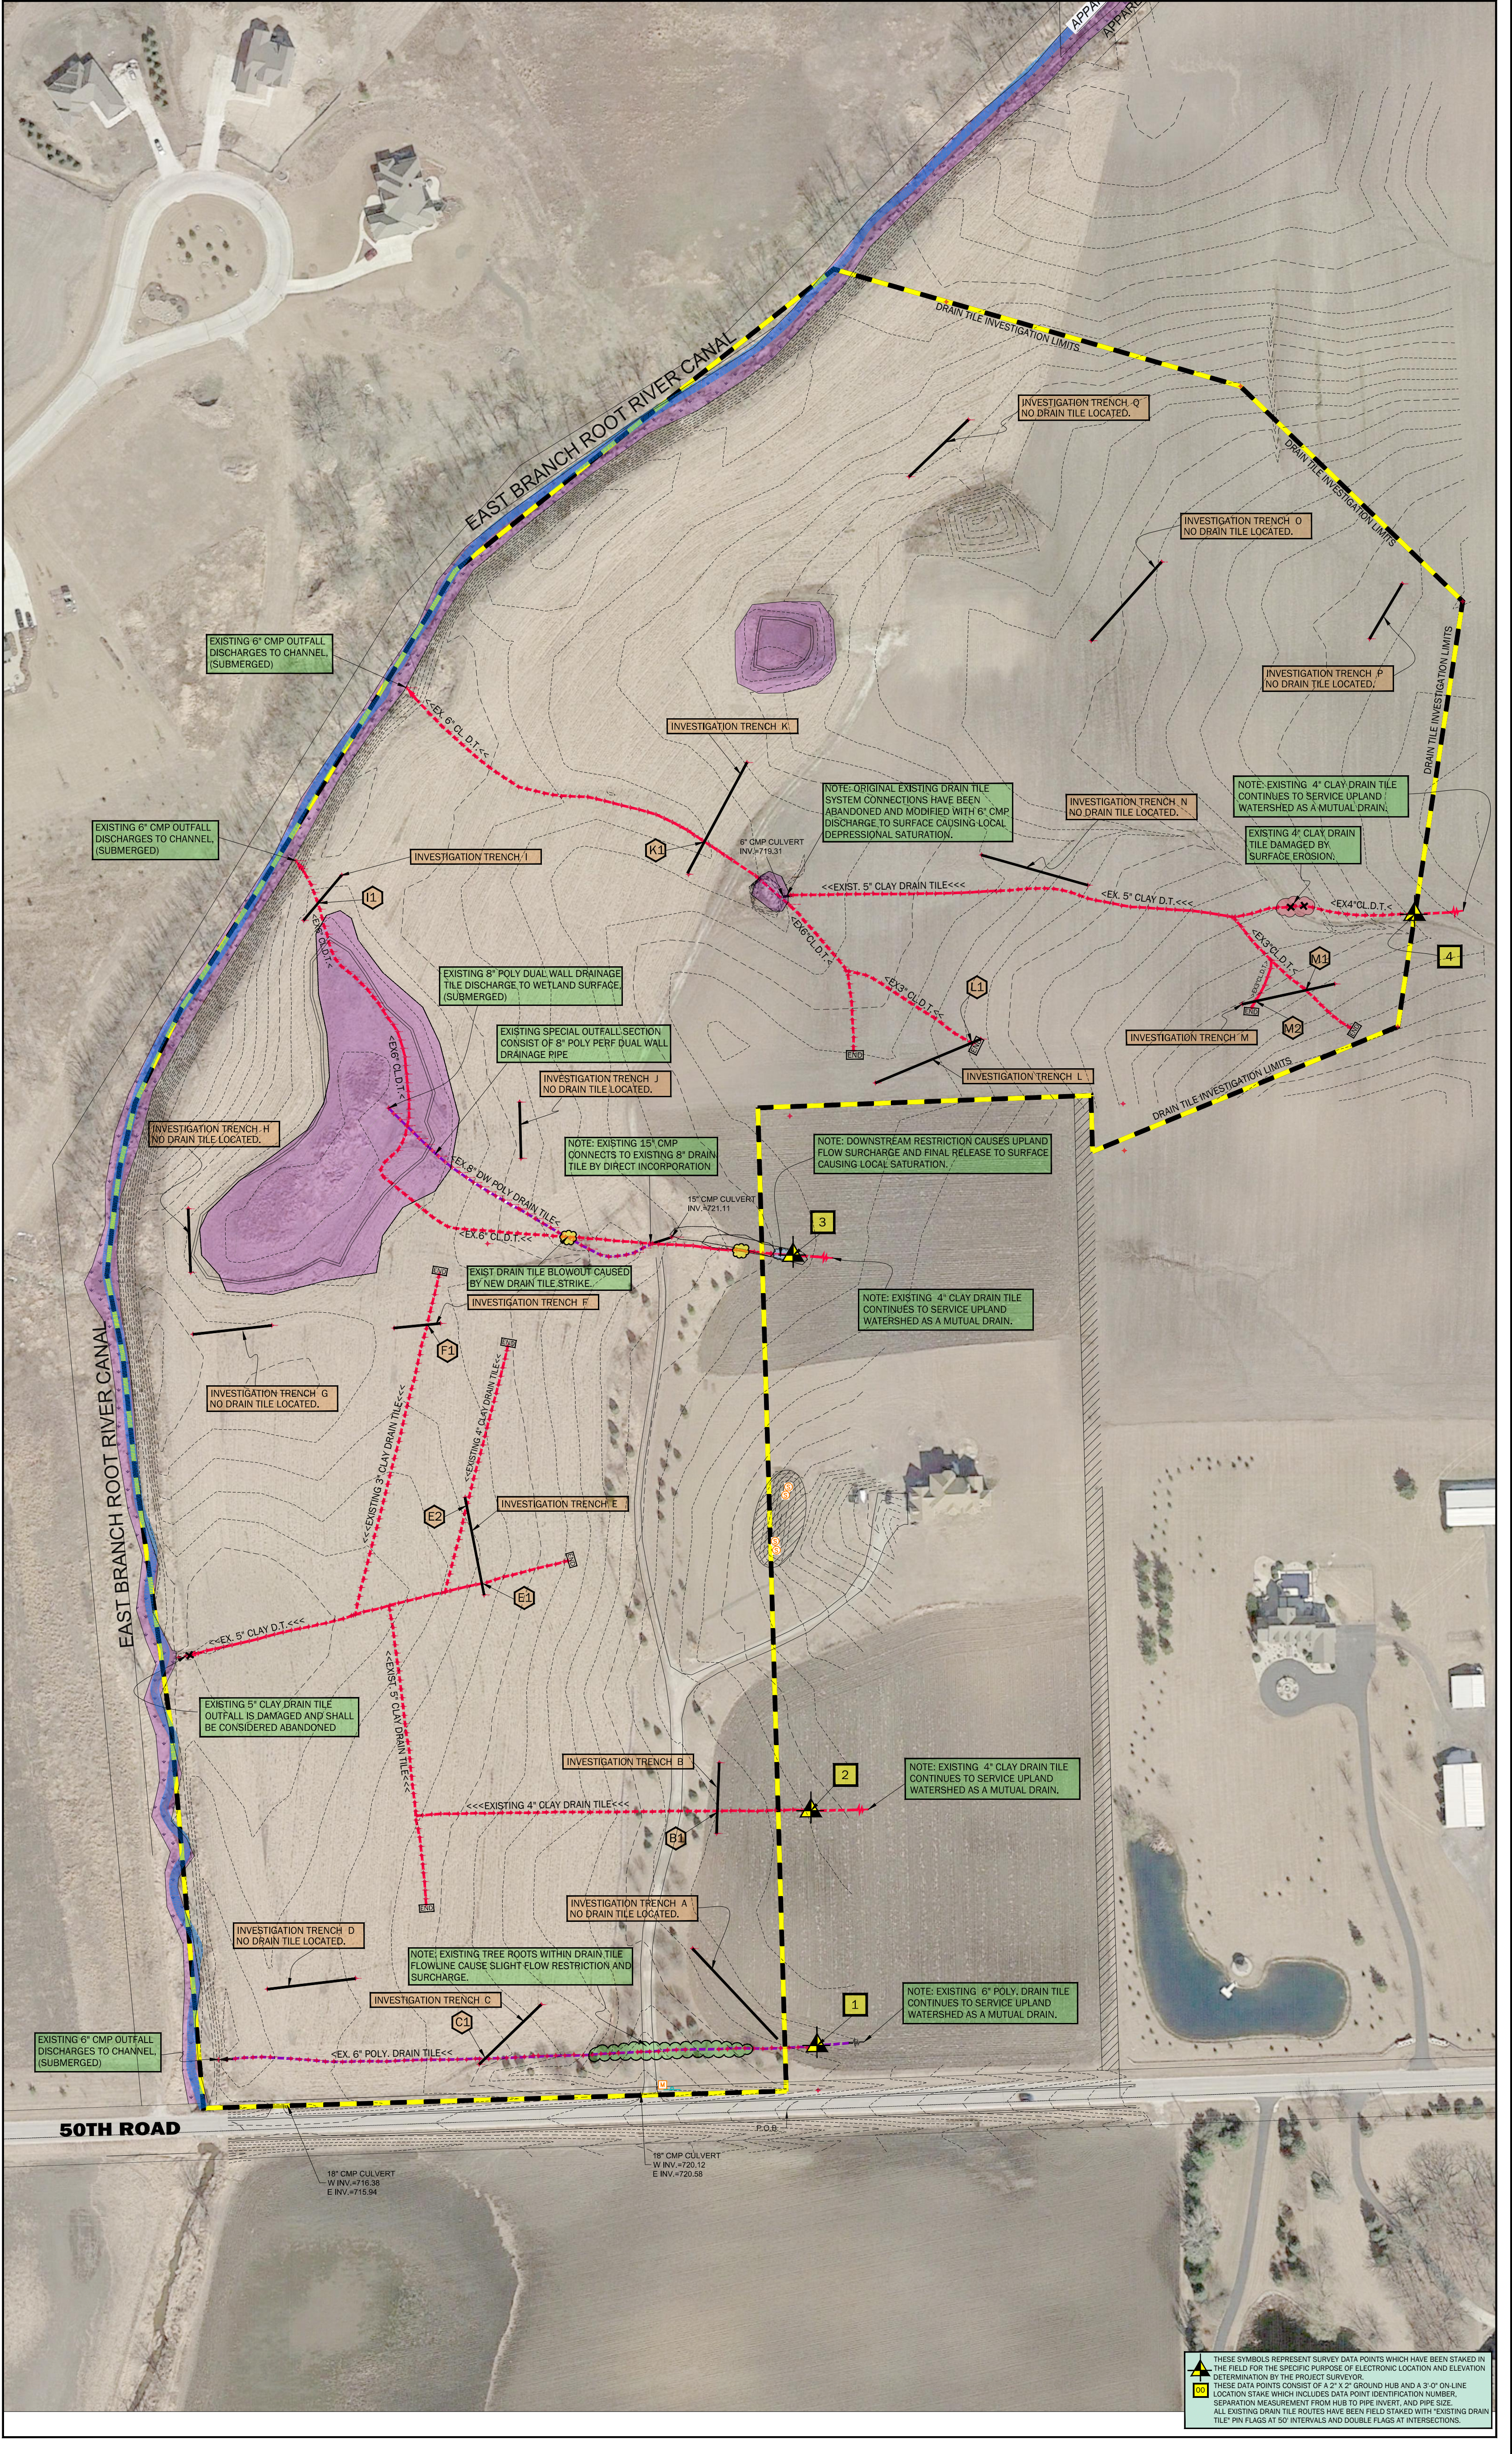
DESCRIPTION CHART NO. 1A:					
ID NO.	SIZE	TYPE / QUALITY	FLOW %	SILT %	DEPTH (IN)
A	4"	CLAY / GOOD	SLIGHT	CLEAN	38"
B	4"	CLAY / GOOD	SLIGHT	CLEAN	38"
C	6"	POLY / GOOD	30%	CLEAN	33"
D	4"	CLAY / GOOD	SLIGHT	CLEAN	33"
E	4"	CLAY / GOOD	SLIGHT	CLEAN	33"
F	4"	CLAY / GOOD	SLIGHT	CLEAN	33"
G	4"	CLAY / GOOD	SLIGHT	CLEAN	33"
H	4"	CLAY / GOOD	SLIGHT	CLEAN	33"
I	4"	CLAY / GOOD	SLIGHT	CLEAN	33"
J	4"	CLAY / GOOD	SLIGHT	CLEAN	33"
K	4"	CLAY / GOOD	SLIGHT	CLEAN	33"
L	4"	CLAY / GOOD	SLIGHT	CLEAN	33"
M	4"	CLAY / GOOD	SLIGHT	CLEAN	33"
N	4"	CLAY / GOOD	SLIGHT	CLEAN	33"
O	4"	CLAY / GOOD	SLIGHT	CLEAN	33"
P	4"	CLAY / GOOD	SLIGHT	CLEAN	33"
Q	4"	CLAY / GOOD	SLIGHT	CLEAN	33"

DESCRIPTION CHART NO. 1B:					
DATA POINT	SIZE	TYPE / QUALITY	FLOW %	SILT %	DEPTH (IN)
1	6"	CLAY / GOOD	30%	CLEAN	45"
2	4"	CLAY / GOOD	SLIGHT	CLEAN	43"
3	4"	CLAY / GOOD	SLIGHT	CLEAN	38"
4	4"	CLAY / GOOD	SLIGHT	CLEAN	38"
