RESOLUTION NO. 2022-29

A RESOLUTION APPROVING A FINAL CERTIFIED SURVEY MAP TO ALLOW FOR THE DIVISION OF THE PARCEL LOCATED AT 17803 2 MILE ROAD INTO A 5.47-ACRE PARCEL AND A 4.20-ACRE PARCEL, SEC. 04, T3N, R21E, VILLAGE OF YORKVILLE, RACINE COUNTY, WISCONSIN (PARCEL ID # 194-03-21-04-034-000); NICHOLAS AND SHANNON HILBERT, OWNER; NICHOLAS AND SHANNON HILBERT, APPLICANT/AGENT

RE: Wetland Identification Report for Project Review Area, located in NW 1/4, NW 1/4, Section 04, Township 03 North, Range 21 E, Town of YORKVILLE, Racine County

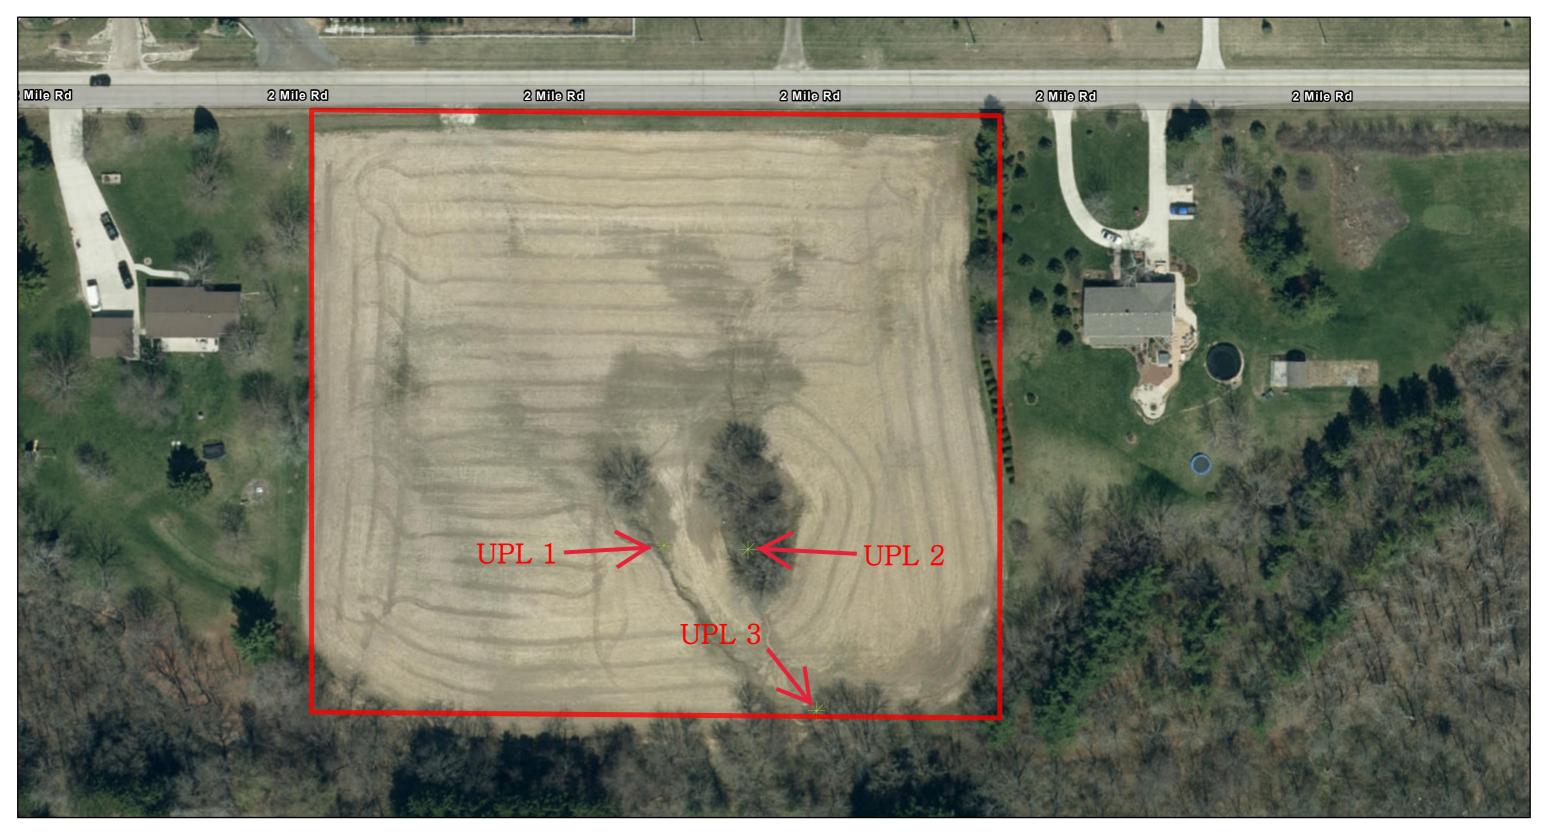
8/8/2022, 8:17:49 AM
Wetland_ID_Data - Polygon layer
Review Area Boundary

Wetland_ID_Data - Point layer

* Upland

Approximate wetland boundaries were identified following 1987 Wetland Delineation Manual and applicable regional supplement guidelines. Wetlands are defined by the 1987 Wetland Delineation Manual as areas that are inundated or saturated by surface or ground water at a frequency and duration sufficient to support, and that under normal circumstances do support, a prevalence of vegetation typically adapted for life in saturated soil conditions. If any wetland areas were detected, their approximate boundaries were sketched onto an aerial photograph (see attached map).

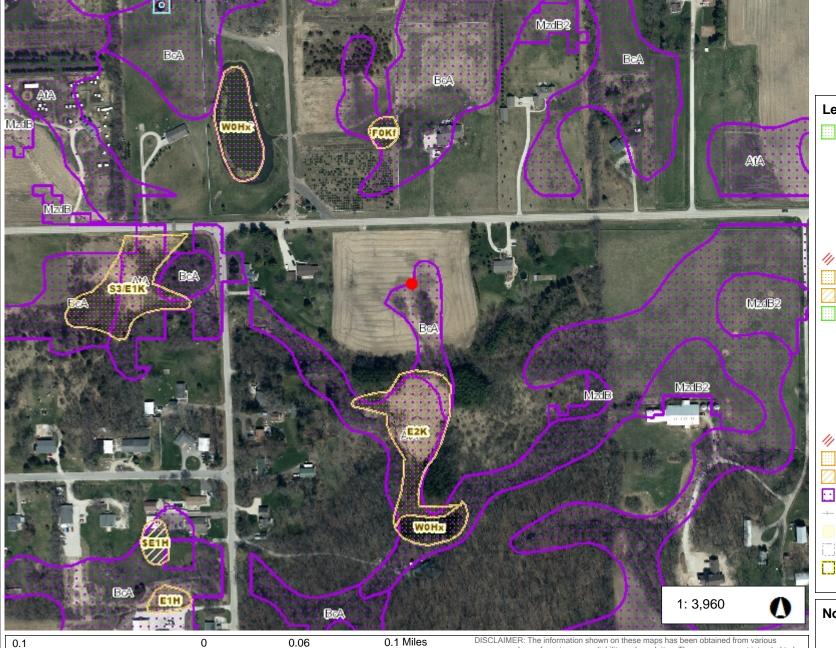
Wisconsin Wetland Inventory Viewer Map

- Results of the antecedent hydrologic condition review indicate the site was likely experiencing normal conditions at the time of the field investigation.
- The WWI has "maximum extent wetland indicators" and hydric soils mapped within the project review area. Enclosed within this report is a figure for reference.

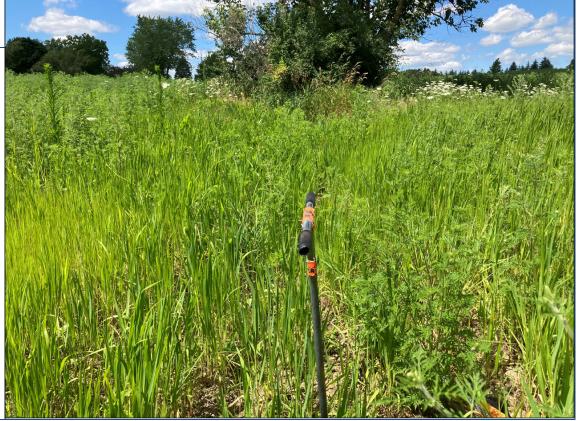
UPL-1 7/28/22

Upland sample point #1.
Photo facing south
downslope.

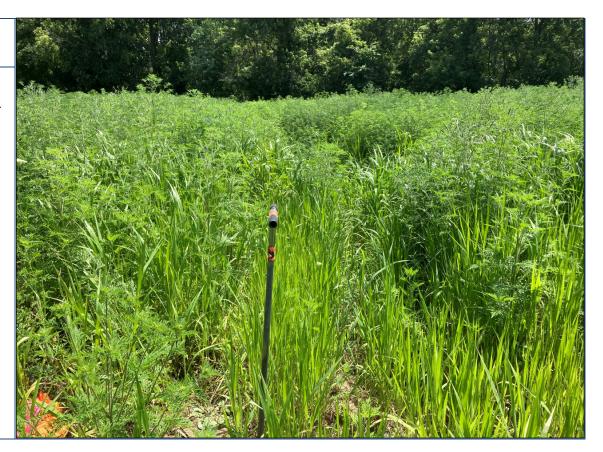
Photo No. Date UPL-2 7/28

Upland sample point #2. Photo facing east. Photo shows wooded plant community in field. Area was likely left vegetated to reduce erosion on the convergent slope.

Sample point taken on wooded area in center of agricultural field. In wooded area and downslope.	Area likely left vegetation to reduce erison on convergent slope. Erosion is present
HYDROLOGY	
Wetland Hydrology Indicators:	Secondary Indicators (minimum of two required)
Primary Indicators (minimum of one is required; check all that app	y) Surface Soil Cracks (B6)
Surface Water (A1) Water-Stained I	Leaves (B9) Drainage Patterns (B10)
High Water Table (A2) Aquatic Fauna (
Saturation (A3) Marl Deposits (6	
Water Marks (B1) Hydrogen Sulfic	
	spheres on Living Roots (C3) Saturation Visible on Aerial Imagery (C9)
Drift Deposits (B3) Presence of Re	<u> </u>
I — · · · · · —	duction in Tilled Soils (C6) Geomorphic Position (D2)
Iron Deposits (B5)Thin Muck Surfa	
Inundation Visible on Aerial Imagery (B7) Other (Explain i	
Sparsely Vegetated Concave Surface (B8)	FAC-Neutral Test (D5)
Field Observations:	
Surface Water Present? Yes No x Depth

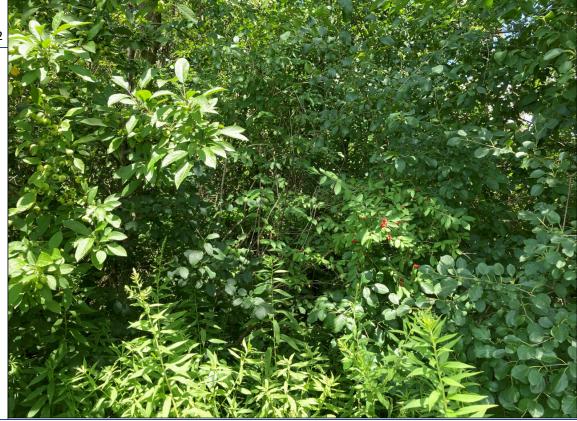
UPL-2

Upland sample point #2. Photo facing north. Photo shows edge of wooded plant community in field. Area was likely left vegetated to reduce erosion on the convergent slope.

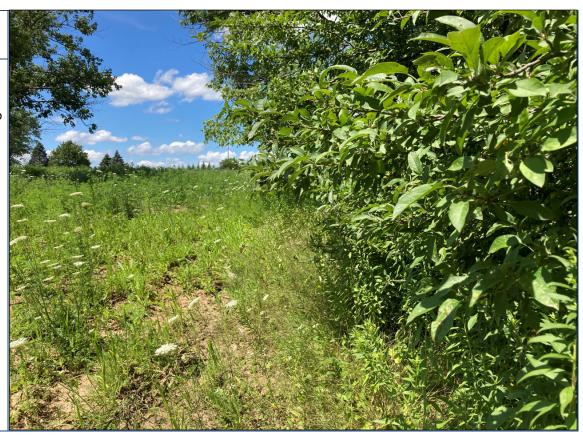
Photo No. UPL-3

Upland sample point #3. Photo facing north uphill. Sample point is located in lowest topographic area of the review area.

Remarks: (Explain alternative procedures he						
Agricultural Field left fallow for one growing s	eason. Sample taken in lowest topograpi	iic alea iii leview alea.				
HYDROLOGY						
Wetland Hydrology Indicators:			(minimum of two required)			
Primary Indicators (minimum of one is requir		Surface Soil Crac				
Surface Water (A1)	Water-Stained Leaves (B9)	Drainage Patterns				
High Water Table (A2)	Aquatic Fauna (B13)	Moss Trim Lines (
Saturation (A3)	Marl Deposits (B15) Dry-Season Water Table (C2)					
— Water Marks (B1)	Hydrogen Sulfide Odor (C1) Crayfish Burrows (C8)					
Sediment Deposits (B2)	Oxidized Rhizospheres on Living Roots (C3) Saturation Visible on Aerial Imagery (C9)					
Drift Deposits (B3)	Presence of Reduced Iron (C4) Stunted or Stressed Plants (D1)					
Algal Mat or Crust (B4)	Recent Iron Reduction in Tilled Soils (C6) Geomorphic Position (D2)					
Iron Deposits (B5)	Thin Muck Surface (C7)Shallow Aquitard (D3)

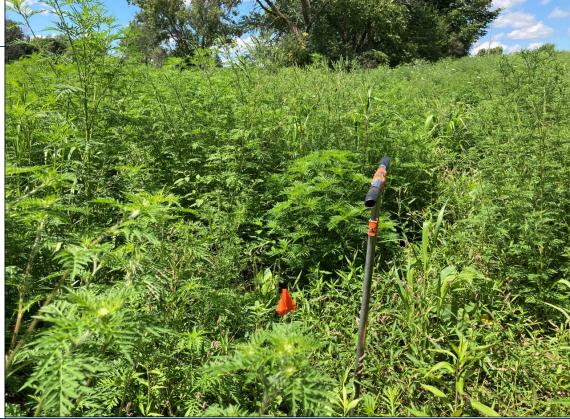
UPL-3 7/28/22

Upland sample point #3. Photo facing south. Sample point is located in lowest topographic area of the review area.
